# Analysis of FY 79 Army Aircraft Accidents

USASC TECHNICAL REPORT  
TR 80-2  
APRIL 1980

Prepared by  
G. Dwight Lindsey

Directorate for  
Investigation, Analysis, and Research

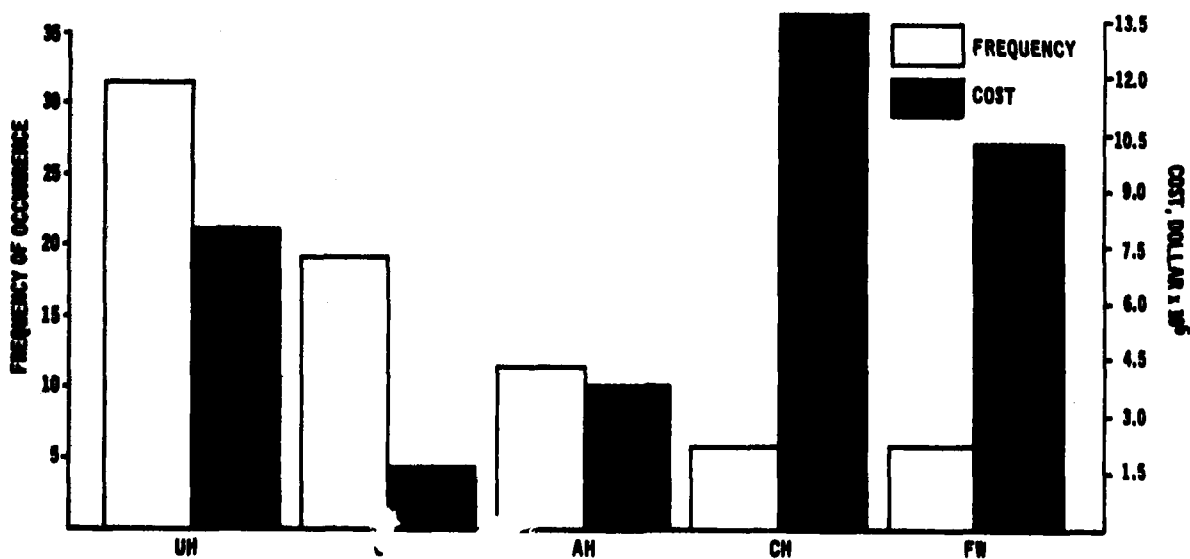
FIGURE 3. — FY 79 Accident Frequency and Cost by Aircraft Type

Frequency of accidents and cost by types of Army aircraft are shown in figure 3. Aircraft types are presented in order of accident frequency.

As shown in figure 3, two aircraft types, the utility and observation helicopters, accounted for most of the Army aircraft accidents (68%). However, most of the dollar losses were the result of accidents involving cargo helicopters and fixed wing (primarily OV-1) aircraft.

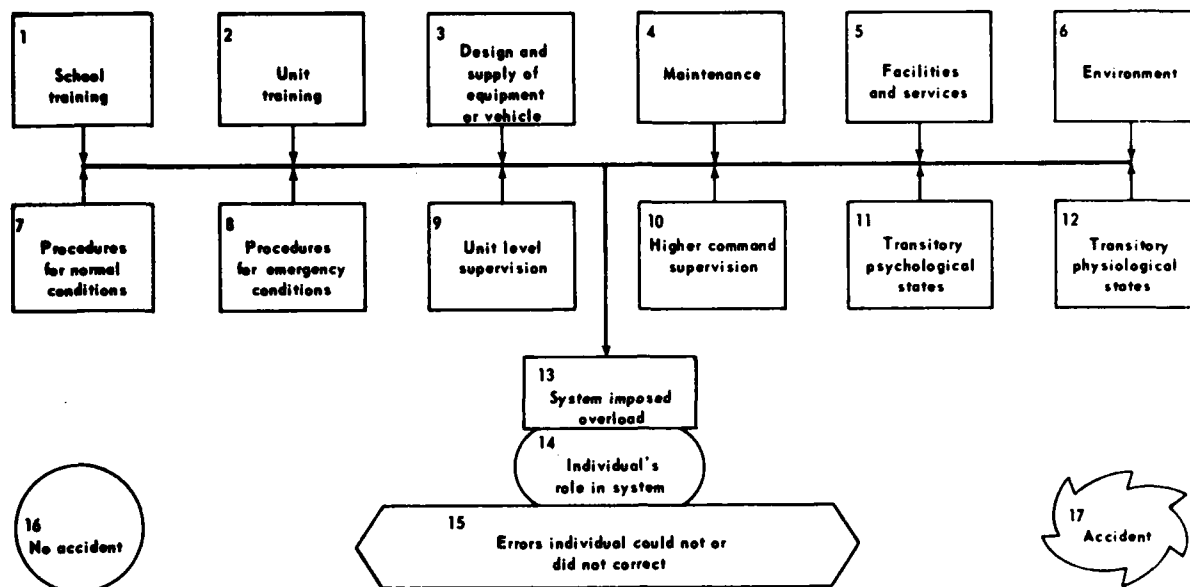
FIGURE E-1.—Model of Human Error Accident

The models used for the human error accident and the material failure/malfunction accident are shown in figures 1 and 2 of appendix E. Information from the TEIR and FIRE analyses was then placed into a format designed for ease of data coding, computer processing, and use in the collective analysis.

Figure E-1 presents a model of the human error accident. The premise of this model is that when one or more of the 12 basic elements of the aviation system do not operate as intended, an overload (item 13) is placed on the man's role in the system (item 14). That is, the man must continue to perform normal tasks while correcting for the abnormal system condition. If the overload is of such magnitude or persistence that the man cannot cope with it and continue to perform normal tasks, he begins to make errors (item 15). Most of these errors do not result in an accident (item 16). But, as the magnitude and frequency of errors increase, the likelihood of the error causing an accident increases. When an accident occurs that has been caused by a human error(s), it is probable that this error has occurred many times before the accident happened. Also, it is likely to continue to occur unless some remedial action is taken to correct the system inadequacy causing the error.

This basic model was used to develop the approach outlined in table E-1. The approach requires the accident investigation board to identify what happened, what caused or allowed it to happen, and what to do about it (3W) with respect to man, machine, the environment, and their interaction. This report only addresses the man and machine cause factors.

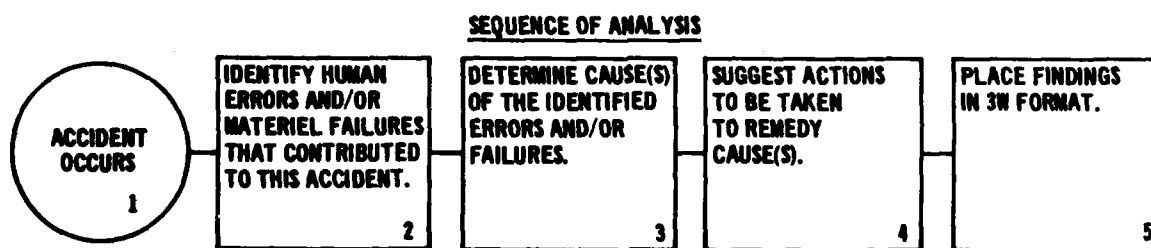
FIGURE E-3. — Identification of Hazards in Each Individual Accident

**Individual Accident Analysis.** Figure E-3 shows the general process by which the individual analysis of an accident was accomplished.
